1902.  
NEW ZEALAND.

# INSPECTION OF COAL-MINES REPORT.

Mr. J. HAYES, F.S.Sc., Inspecting Engineer, to the UNDER-SECRETARY, Mines Department.  
SIR,— Mines Department, Wellington, 23rd April, 1902.

I have the honour to submit my annual report (covering those of the Inspectors of Mines for the several districts) for the year ending 31st December, 1901.

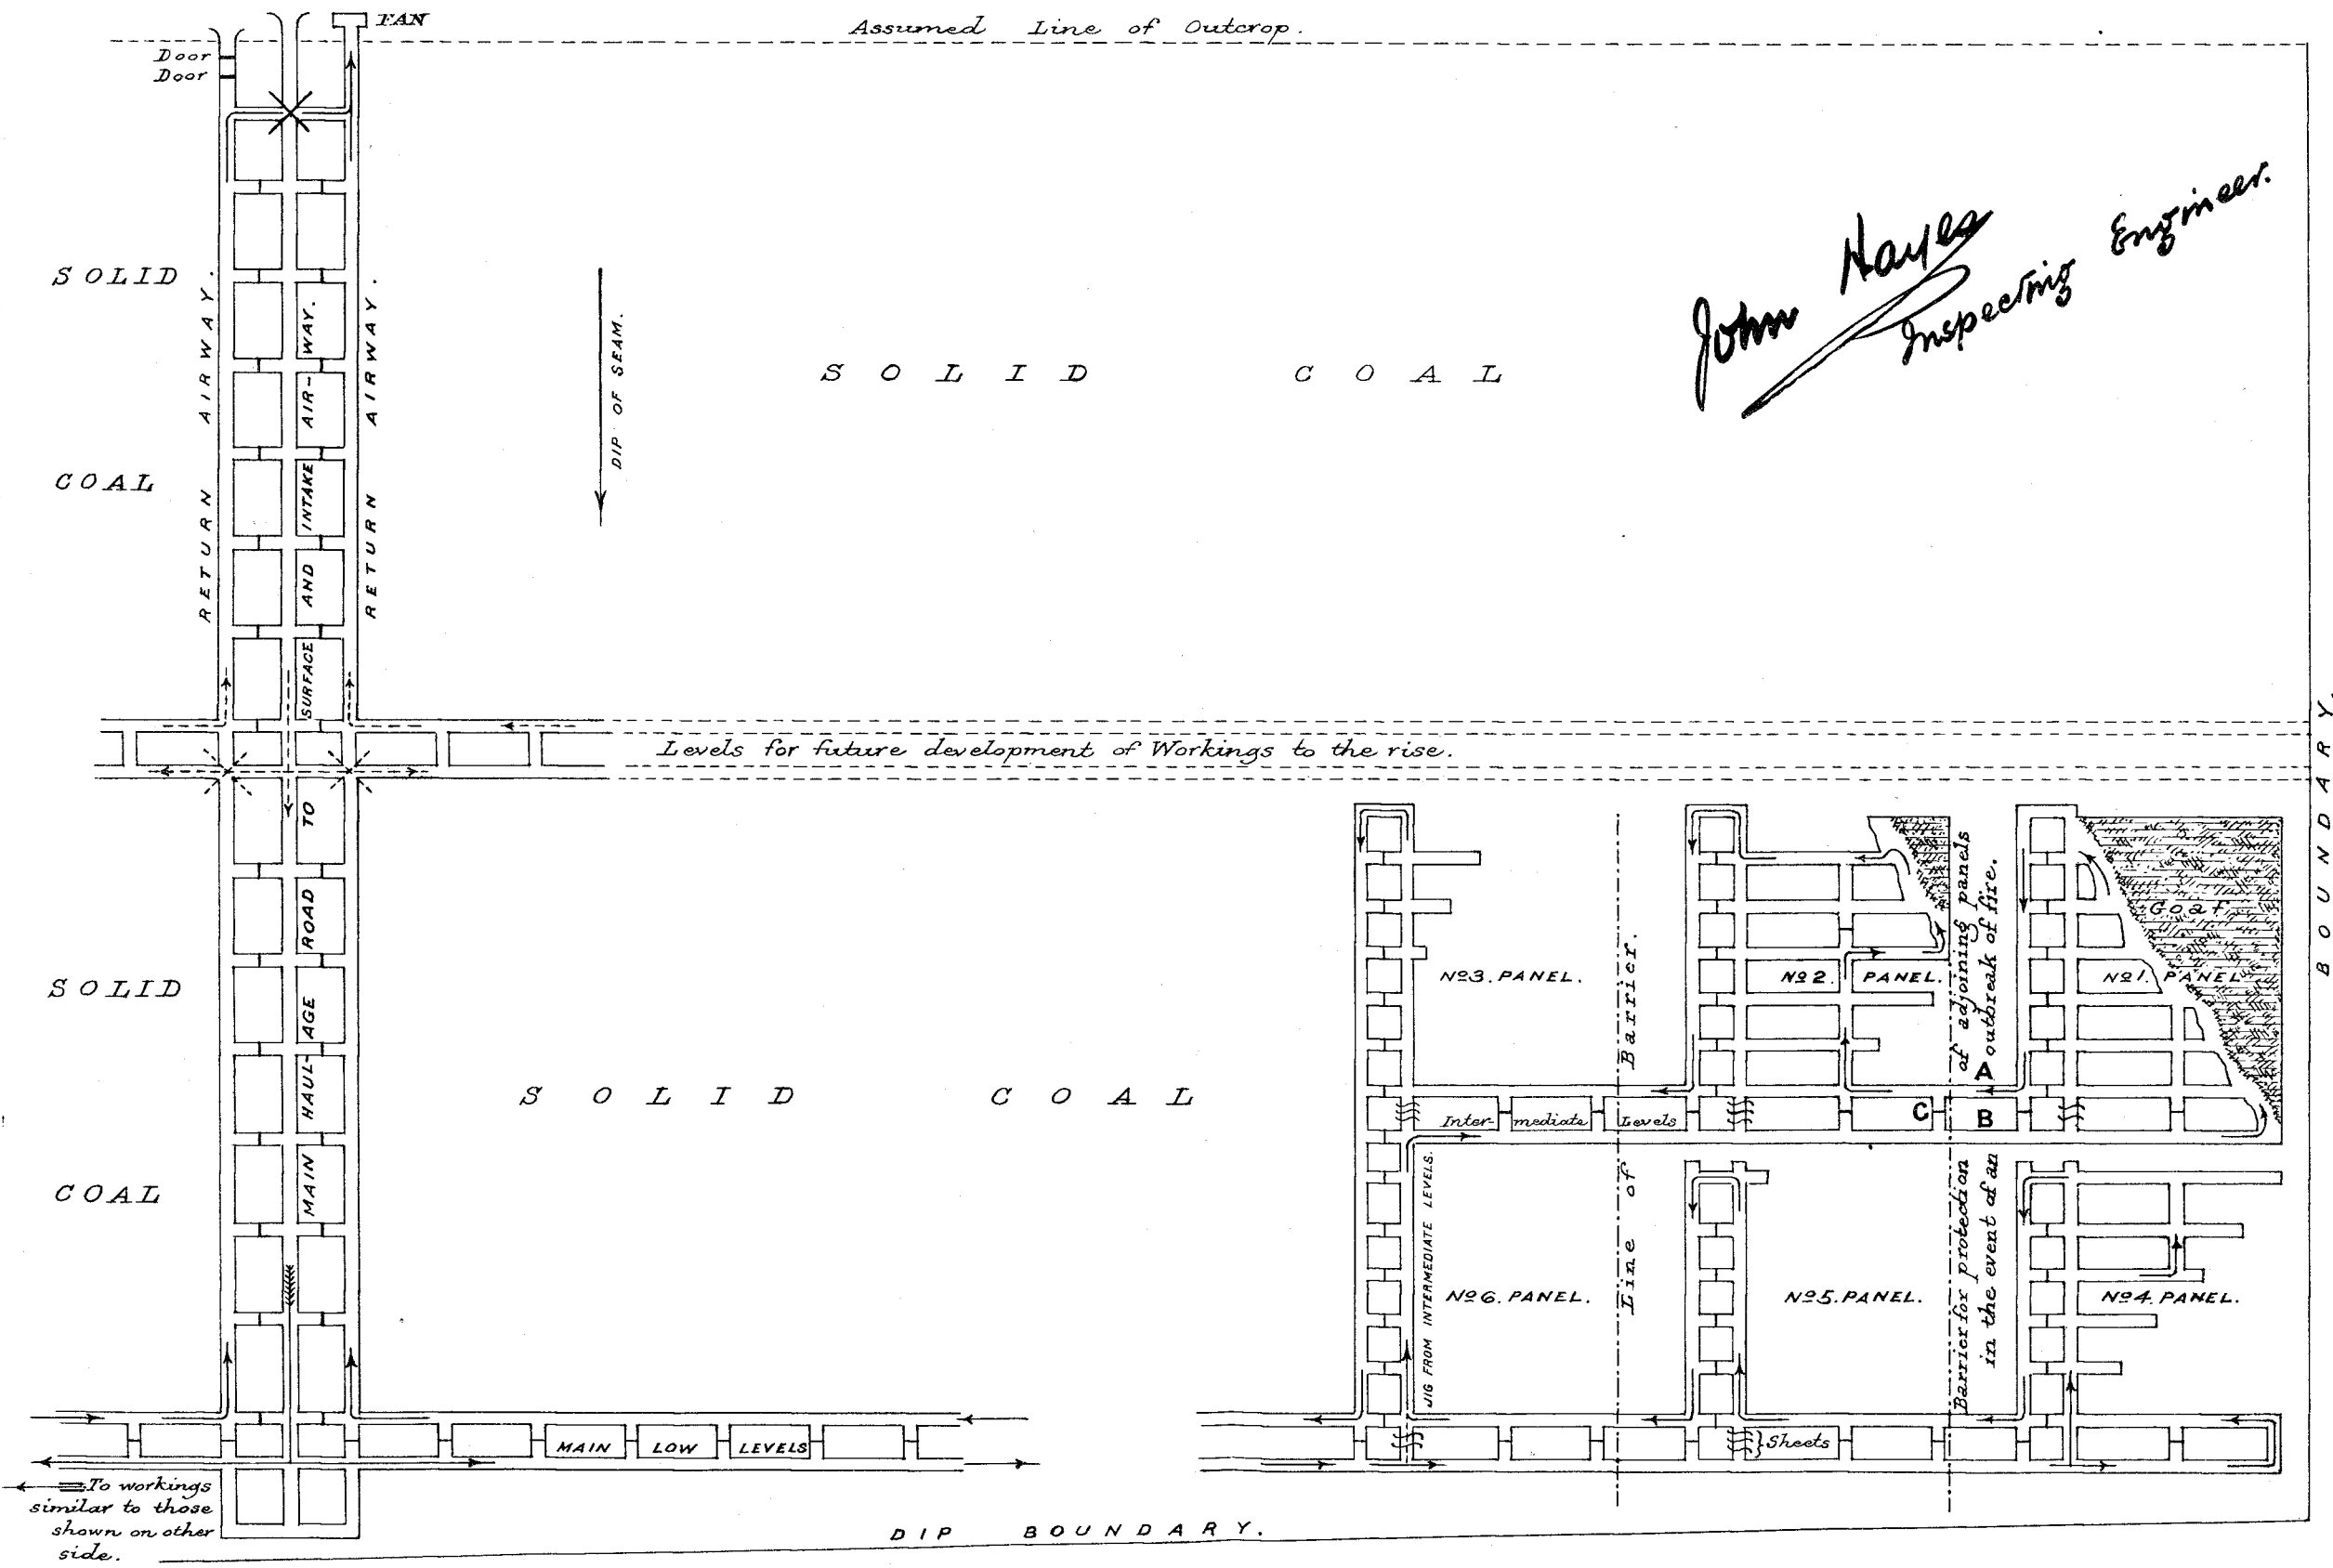
Sketch Plan to illustrate notes on

The liability to the spontaneous ignition of worked-out (or partially worked) ground in our coal-mines has led me to give some consideration to the subject, and in connection with this matter I trust that the combination of an extensive Home as well as colonial experience may be considered sufficient to justify my present remarks.

It is well known that coals of a hydrous character are more susceptible to spontaneous ignition than those of a more anhydrous nature, and on this account the occurrence of fire in mines working brown coal is more frequent and usual than in the case of mines where bituminous or anthracite coals are worked. In consequence of fires a very considerable tonnage of coal has been irrecoverably lost. This is not to be wondered at in the case of many mines in the colony which have been laid out on a system (or, in many instances, a want of system) whereby efforts to localise the extent and effects of a fire can seldom be crowned with success. It must not be inferred that the management is to be entirely blamed for this, although a want of special knowledge and experience in the laying-out of underground workings in such a manner as to minimise the risk of damage by fire is frequently apparent. Owners of mines are frequently to blame for not seeking the advice of mining engineers who have had practical experience in this matter, and also for requiring a fairly large output long before it is possible to open out the mine sufficiently to warrant such an output being legitimately obtained. It is quite a common but altogether erroneous idea with persons whose knowledge of these things is limited, that a good output can be obtained, and profits made, almost as soon as the coal has been struck, and this very notion on the part of mine shareholders, combined with shortage of capital, has been responsible for the loss of very large areas of coal not only in this colony, but all over the world. If a colliery is to be worked successfully there must be some well-defined plan laid out for the general development of the field, and this applies equally to both large and small holdings. Our coalfields are a national asset, and every care ought to be exercised to prevent undue loss or waste. There is no doubt that the granting of leases in excess of reasonable and legitimate requirements to men who have neither the capital nor knowledge to work the areas to the best advantage has been productive of much loss of coal by fires and other causes. Such men seldom have any idea as to the sizes of pillars which should be left in the inward working to allow of safe and economical extraction from the boundary backwards, nor the means nor knowledge to keep such pillars in proper shape, the result being that pillars are often found to be only feet in width where they ought to be yards, or even fathoms. With such haphazard mining a "crush" or "creep" may be brought on, and a fire ensue. Under a want of system such as this—no provision having been made to effectively deal with such a contingency as fire—the closing of the mine and consequent loss of coal is almost inevitable.

The point I now wish to impress is, that where there is a natural tendency towards spontaneous ignition the plan to be adopted for working a mine should receive very careful and serious consideration, and some method ought to be devised by which fires can be localised and kept under control. The accompanying sketch-plan will help to illustrate my meaning; and although I do not claim that the method shown will answer all requirements—different conditions requiring different treatment—yet the general system (which may be modified to meet local conditions) is one which I think is worth adoption, and has been proved of undoubted value in some of the English coalfields which are peculiarly liable to fires, and where thick seams, lying at a high angle of inclination, are worked.
