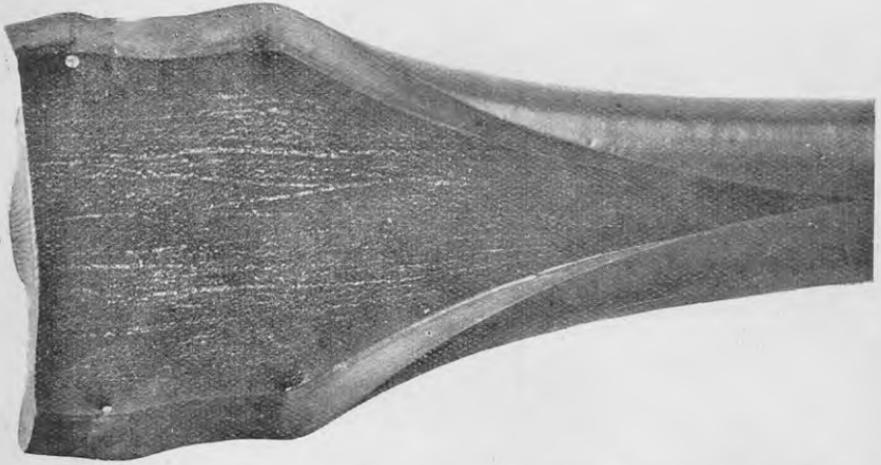
FIG. 1. LONG MILK-RUBBER AFTER TWELVE MONTHS' USE AND CLEANING DAILY WITH BOILING WATER, WASHING-SODA, AND THE USE OF A BRUSH AND SCRAPER. NOTE THE SCORED INNER SURFACE OF THE TUBE.

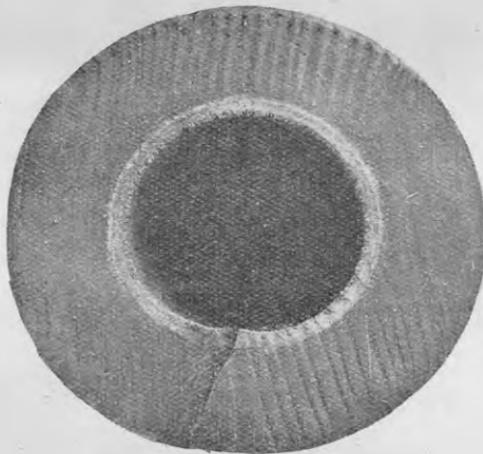
FIG. 2. END VIEW OF THE SAME RUBBER (FIG. 1). THE WHITISH INNER CIRCLE INDICATES THE SCORED SURFACE OF THE TUBE.
