THE JAPS.' DEFENCES ON BETIO

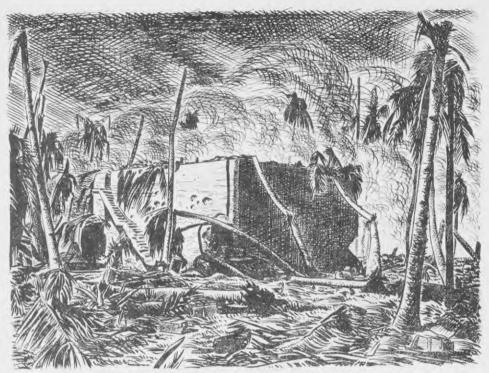
This drawing from an official United States Marine Corps photograph shows one of the forts the Japs. had built on Betio. In some of the blockhouses, a concrete emplacement 5 ft. thick was covered with palm logs 18 in. in diameter. Outside the logs were angle irons of railway-rails, and over all was 10 ft. to 12 ft. of sand and coral.

by a naval barrage that pumped 1,500 tons of shells on to Betio's square mile. Yet the Marines found that this tremendous concentration of explosions had done little to weaken the efficacy of the Jap. defences.
