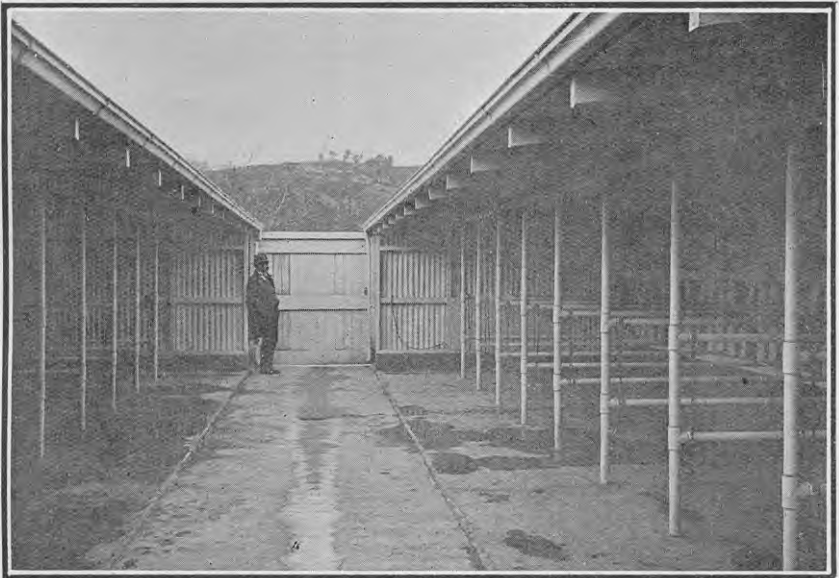
Fig. 2 is an interior view of the shed, and gives a good idea of the roominess and comfort obtained. Note the leg-ropes attached to

FIG. 2. INTERIOR VIEW OF THE MILKING-SHED.

rings in the ironwork, and the handles and pulleys immediately above for releasing the head-bails. On the under side of the bail-heads runs a perforated sanitary pipe, to which water is supplied immediately after milking. This sprays the floor, which is then brushed down. The entire shed, with the exception of the concrete base, is painted white. The long roof to the centre walk affords ample protection for the milkers in wet weather. There is a small room on either side between the last bail and the outside wall at the eastern end. One of these rooms is used for holding the milk during milking, and the other by the milkers for washing, &c.
